YOUR ONESURVEY
HOME REPORT

26 Bow Butts
Crail, Anstruther
KY10 3UR

SINGLE SURVEY

Single Survey

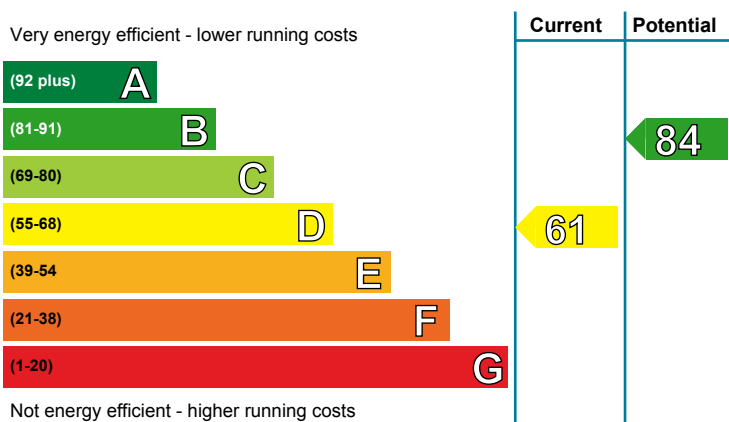
Energy Efficiency Rating

This graph shows the current efficiency of your home, taking into account both energy efficiency and fuel costs. The higher this rating, the lower your fuel bills are likely to be.

Your current rating is **band D (61)**. The average rating for EPCs in Scotland is **band D (61)**.

The potential rating shows the effect of undertaking all of the improvement measures listed within your recommendations report.

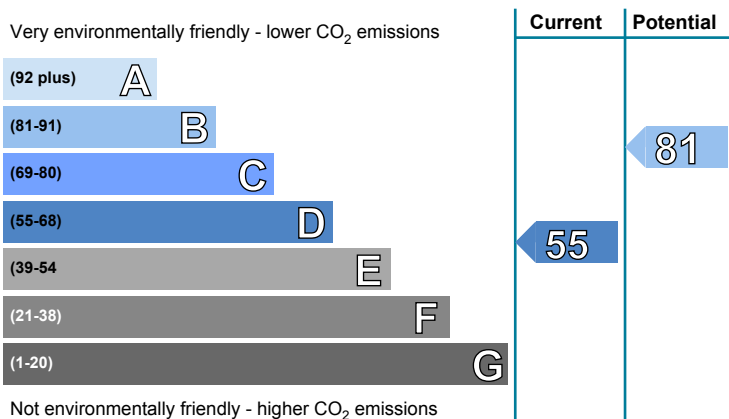
Environmental Impact (CO₂) Rating

This graph shows the effect of your home on the environment in terms of carbon dioxide (CO₂) emissions. The higher the rating, the less impact it has on the environment.
