YOUR ONESURVEY HOME REPORT

4 St. Michaels West Port Cupar KY15 4FB

SINGLE SURVEY

A report on the condition of the property, with categories being rated from 1 to 3.

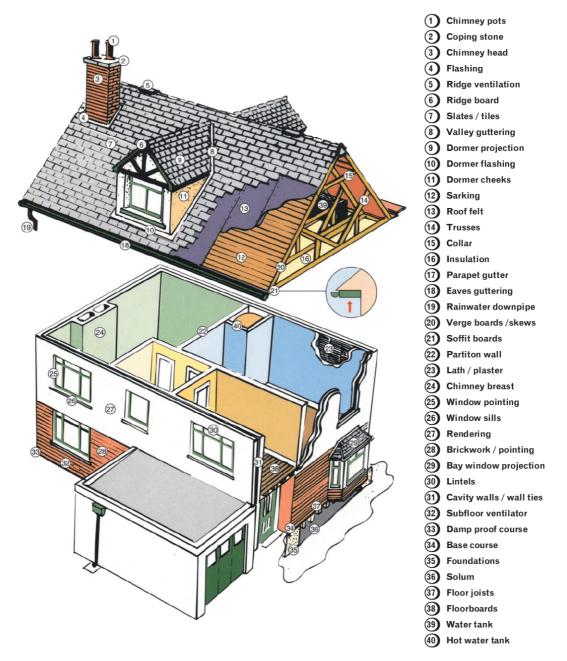
Sectional Diagram showing elements of a typical house

Reference may be made in this report to some or all of the above component parts of the property. This diagram may assist you in locating and understanding these items.
