# YOUR ONESURVEY HOME REPORT

24 Kilrymont Road St. Andrews KY16 8DE

# SINGLE Survey

Surveyor Reference	J4126
Customer	The Client of Lawrie Estate Agents
Selling address	24 Kilrymont Road St. Andrews KY16 8DE

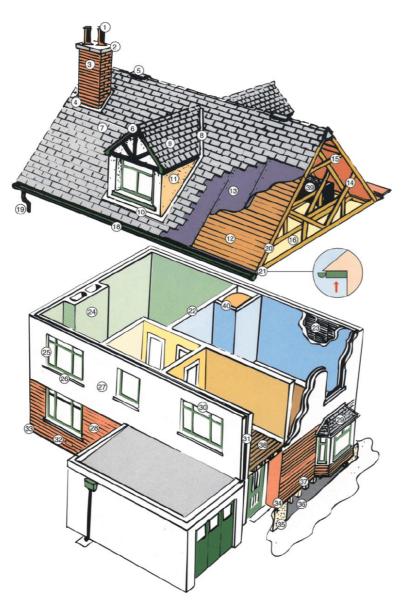
#### Sectional Diagram showing elements of a typical house

Reference may be made in this report to some or all of the above component parts of the property. This diagram may assist you in locating and understanding these items.

Chimney pots Coping stone 2 3 Chimney head 4 Flashing 5 **Ridge ventilation** 6 Ridge board (7) Slates / tiles 8 Valley guttering **9** Dormer projection **Dormer flashing Dormer cheeks** (12) Sarking (13) Roof felt (14) Trusses (15) Collar 16 Insulation 17 Parapet gutter (18) Eaves guttering (19) Rainwater downpipe (20) Verge boards / skews (21) Soffit boards 2 Partiton wall 23 Lath / plaster (24) Chimney breast (25) Window pointing (26) Window sills (27) Rendering (28) Brickwork / pointing (29) Bay window projection 30 Lintels (31) Cavity walls / wall ties 32 Subfloor ventilator 33 Damp proof course (34) Base course **35** Foundations (36) Solum
