YOUR ONESURVEY HOME REPORT

42 Sandylands Road Cupar KY15 5JS

SINGLE Survey

Single Survey

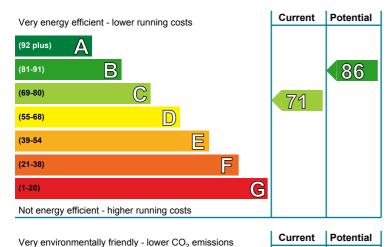
Energy Efficiency Rating

This graph shows the current efficiency of your home, taking into account both energy efficiency and fuel costs. The higher this rating, the lower your fuel bills are likely to be.
