HOME REPORT

Tailabout Farmhouse
Pitscottie Road
Cupar
KY15 5ST

SINGLE SURVEY

Single Survey

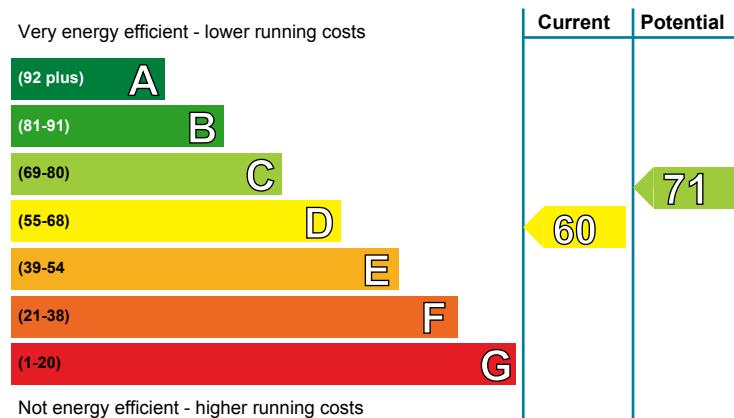
Energy Efficiency Rating

This graph shows the current efficiency of your home, taking into account both energy efficiency and fuel costs. The higher this rating, the lower your fuel bills are likely to be.

Your current rating is **band D (60)**. The average rating for EPCs in Scotland is **band D (61)**.

The potential rating shows the effect of undertaking all of the improvement measures listed within your recommendations report.

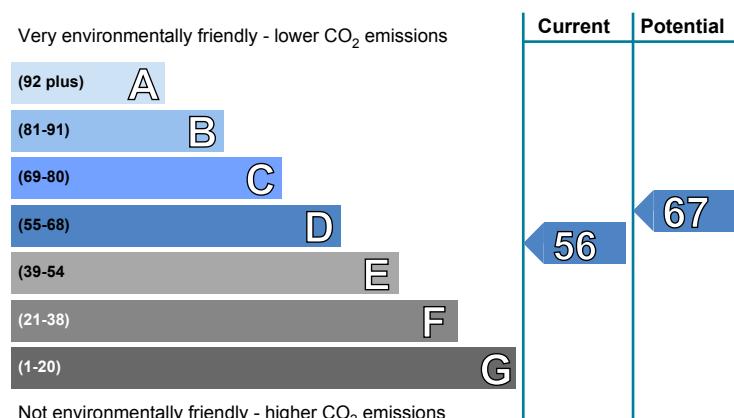
Environmental Impact (CO₂) Rating

This graph shows the effect of your home on the environment in terms of carbon dioxide (CO₂) emissions. The higher the rating, the less impact it has on the environment.
