YOUR ONESURVEY  
**HOME REPORT**

10 Tay Street  
Newburgh  
Cupar  
KY14 6AL

# SINGLE SURVEY

A report on the condition of the property, with categories being rated from 1 to 3.

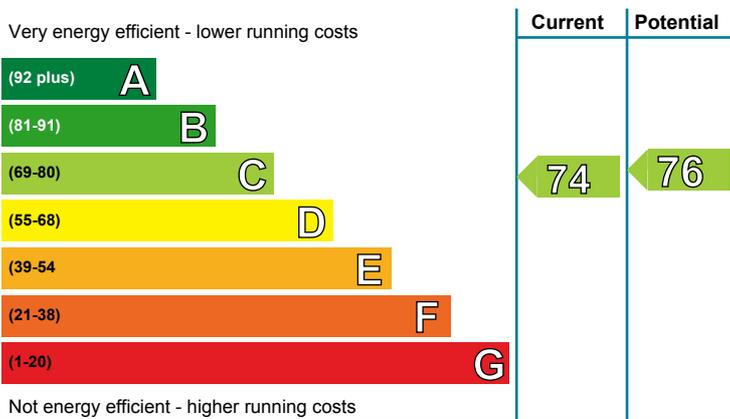
## Energy Efficiency Rating

This graph shows the current efficiency of your home, taking into account both energy efficiency and fuel costs. The higher this rating, the lower your fuel bills are likely to be.

Your current rating is **band C (74)**. The average rating for EPCs in Scotland is **band D (61)**.

The potential rating shows the effect of undertaking all of the improvement measures listed within your recommendations report.

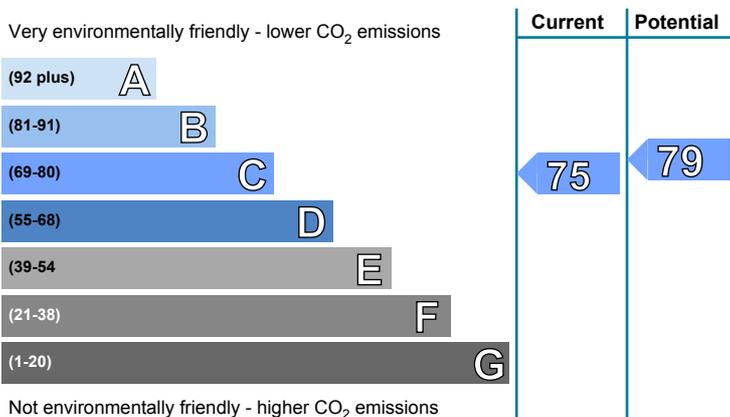
## Environmental Impact (CO<sub>2</sub>) Rating

This graph shows the effect of your home on the environment in terms of carbon dioxide (CO<sub>2</sub>) emissions. The higher the rating, the less impact it has on the environment.
