# Home Report

# ENERGY REPORT

Dwelling Address	1 Balrymonth Court, ST. ANDREWS, KY16 8XT
Reference	008568
Assessment Date	27/04/2026
Submission Date	04/05/2026
Property Type	Detached House
Total Floor Area	107 m <sup>2</sup>

# Single Survey

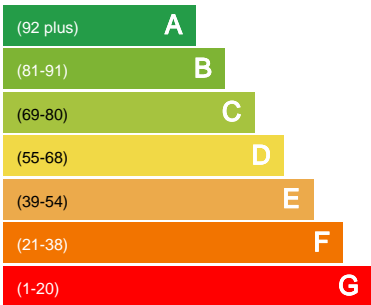
## Energy Efficiency Rating

Very energy efficient - lower running costs
