# YOUR ONESURVEY HOME REPORT

9 Canongate  
St. Andrews  
KY16 8RT

# SINGLE SURVEY

A report on the condition of the property, with categories  
being rated from 1 to 3.

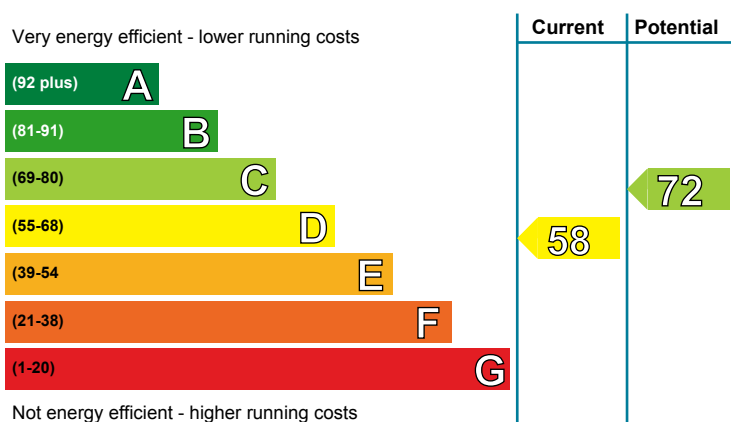
## Energy Efficiency Rating

This graph shows the current efficiency of your home, taking into account both energy efficiency and fuel costs. The higher this rating, the lower your fuel bills are likely to be.

Your current rating is **band D (58)**. The average rating for EPCs in Scotland is **band D (61)**.

The potential rating shows the effect of undertaking all of the improvement measures listed within your recommendations report.

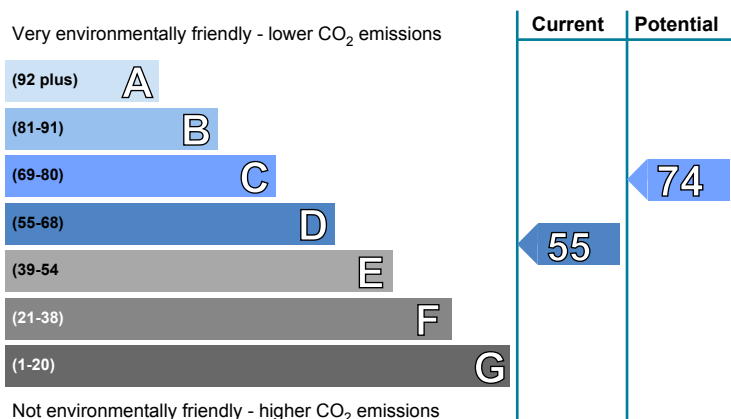
## Environmental Impact (CO<sub>2</sub>) Rating

This graph shows the effect of your home on the environment in terms of carbon dioxide (CO<sub>2</sub>) emissions. The higher the rating, the less impact it has on the environment.
